National Register of Historic Places Registration Form

Historic name: Sears, Roebuck & Company Mail Order Building (AMENDMENT)

Street & number: 2650 East Olympic Boulevard

SEARS, ROEBUCK & CO. MAIL ORDER BUILDING
ATTACHMENT C:
SCHEMATIC DIAGRAM, INCLUDING PHOTO KEY
AND
FLOOR BY FLOOR CONSTRUCTION HISTORY

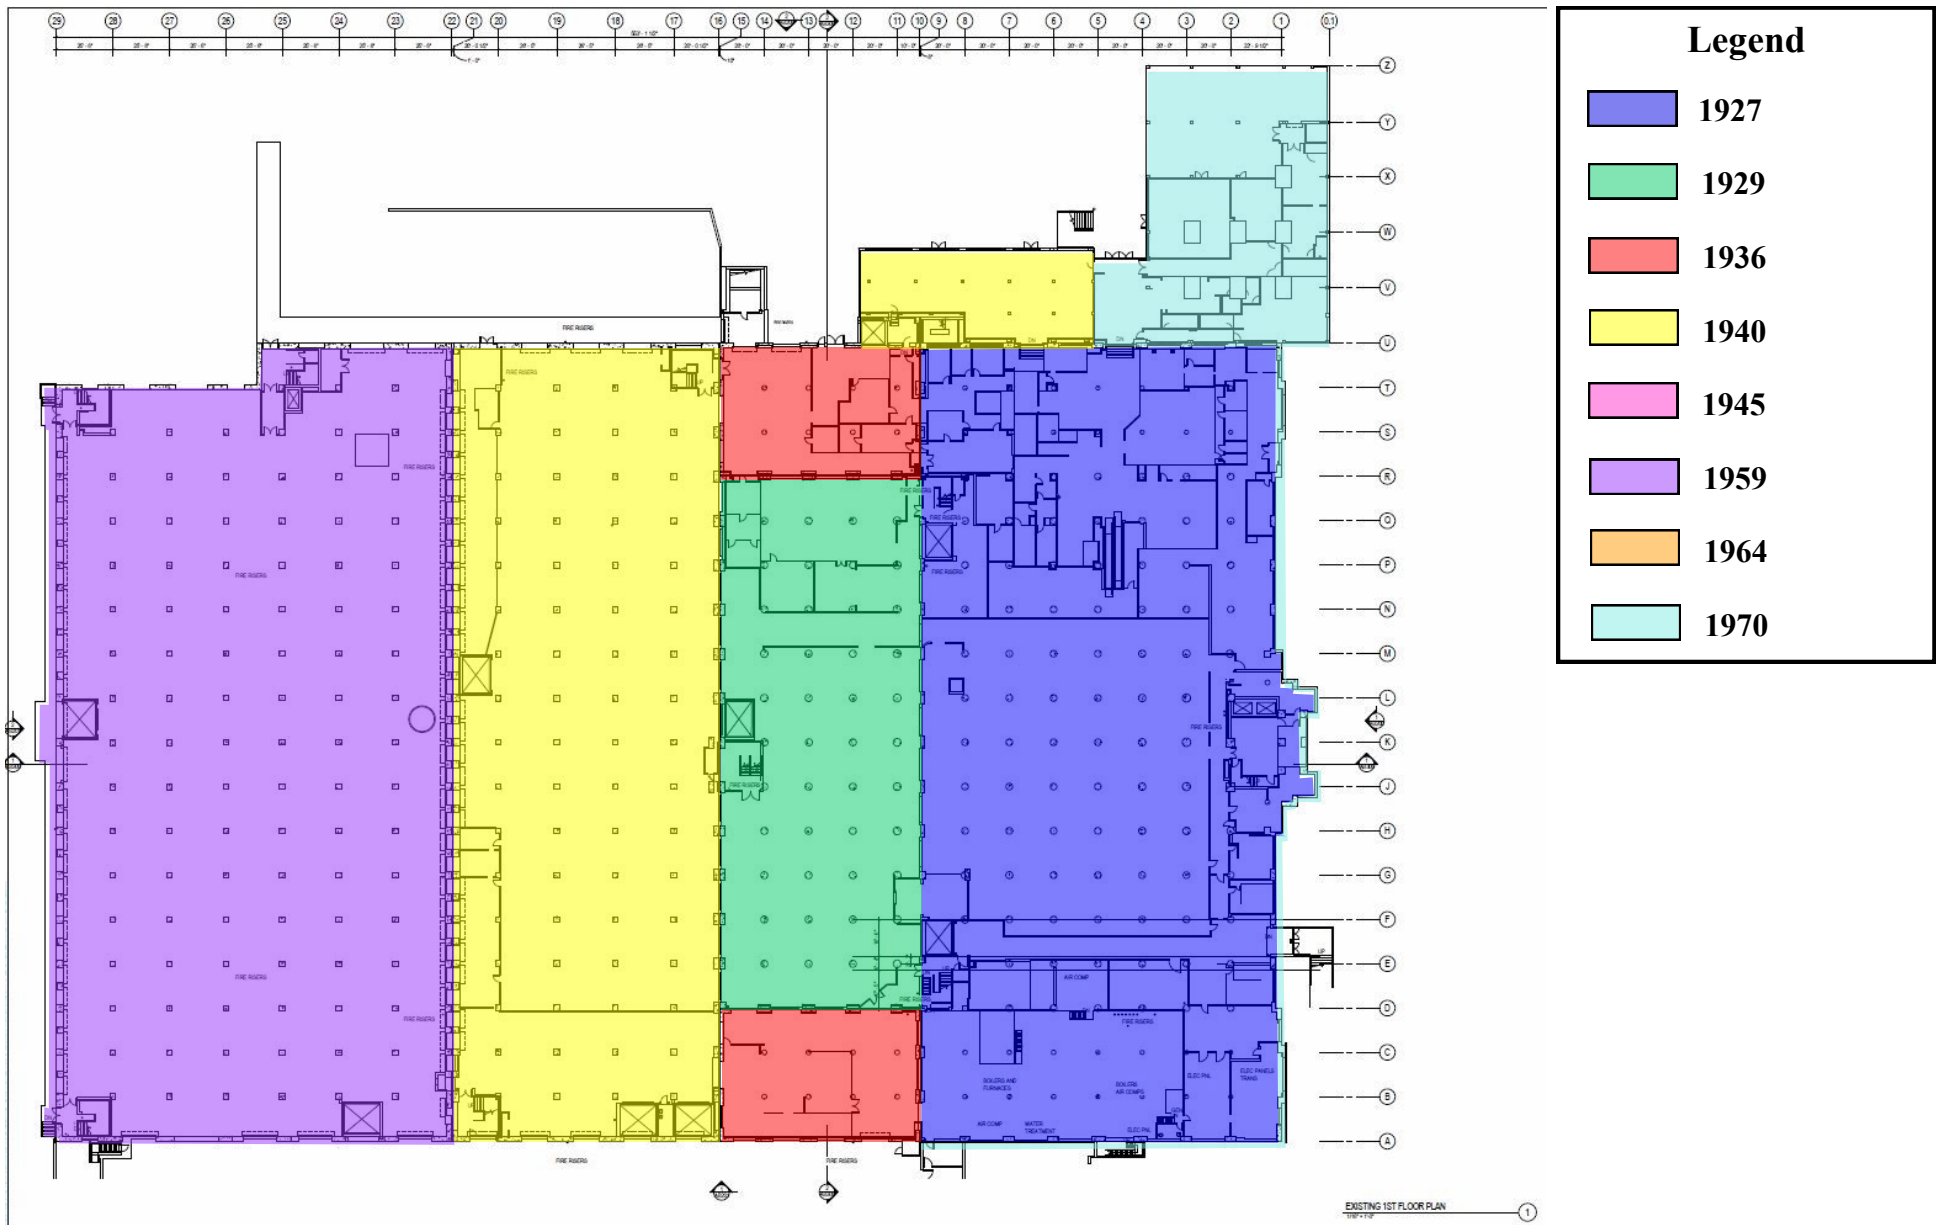
**NATIONAL REGISTER AMENDMENT
SEARS, ROEBUCK, & COMPANY MAIL ORDER BUILDING
2650 EAST OLYMPIC BOULEVARD
ATTACHMENT C: FLOOR-BY-FLOOR CONSTRUCTION HISTORY**

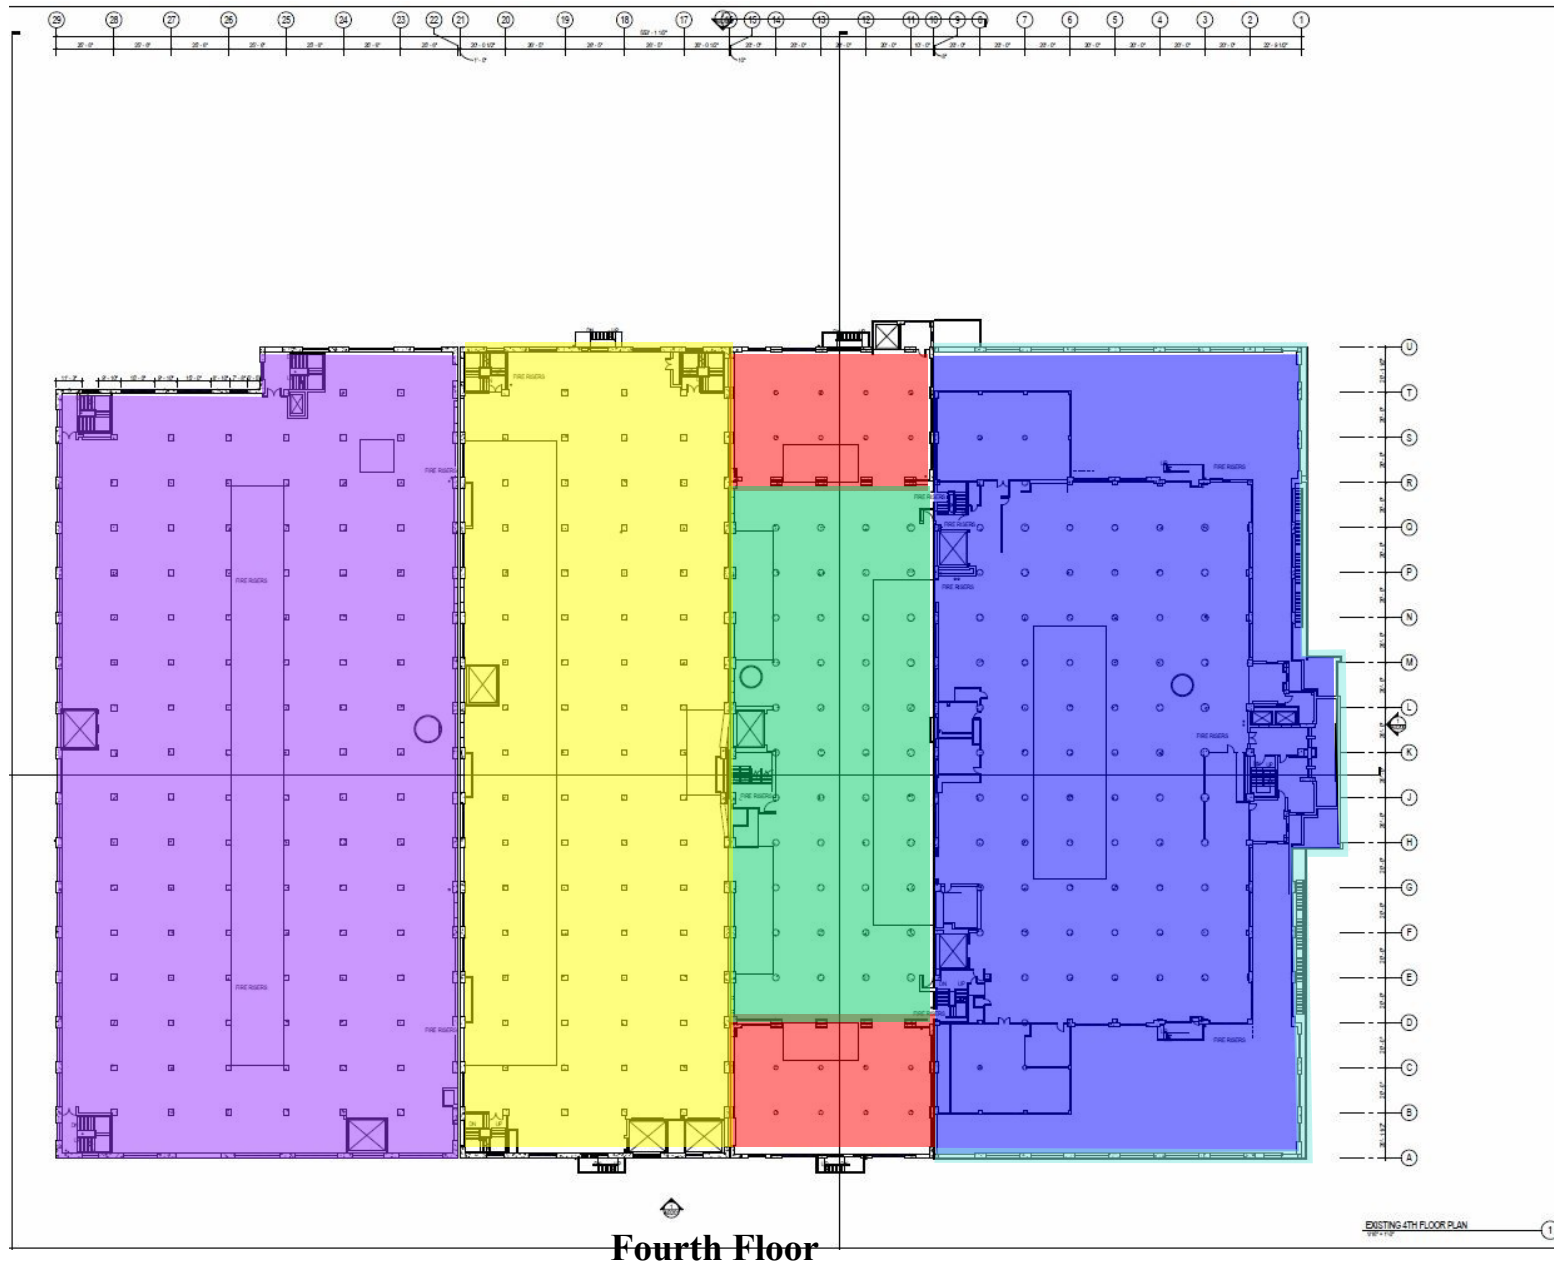
**NATIONAL REGISTER AMENDMENT
SEARS, ROEBUCK, & COMPANY MAIL ORDER BUILDING
2650 EAST OLYMPIC BOULEVARD
ATTACHMENT C: FLOOR-BY-FLOOR CONSTRUCTION HISTORY**

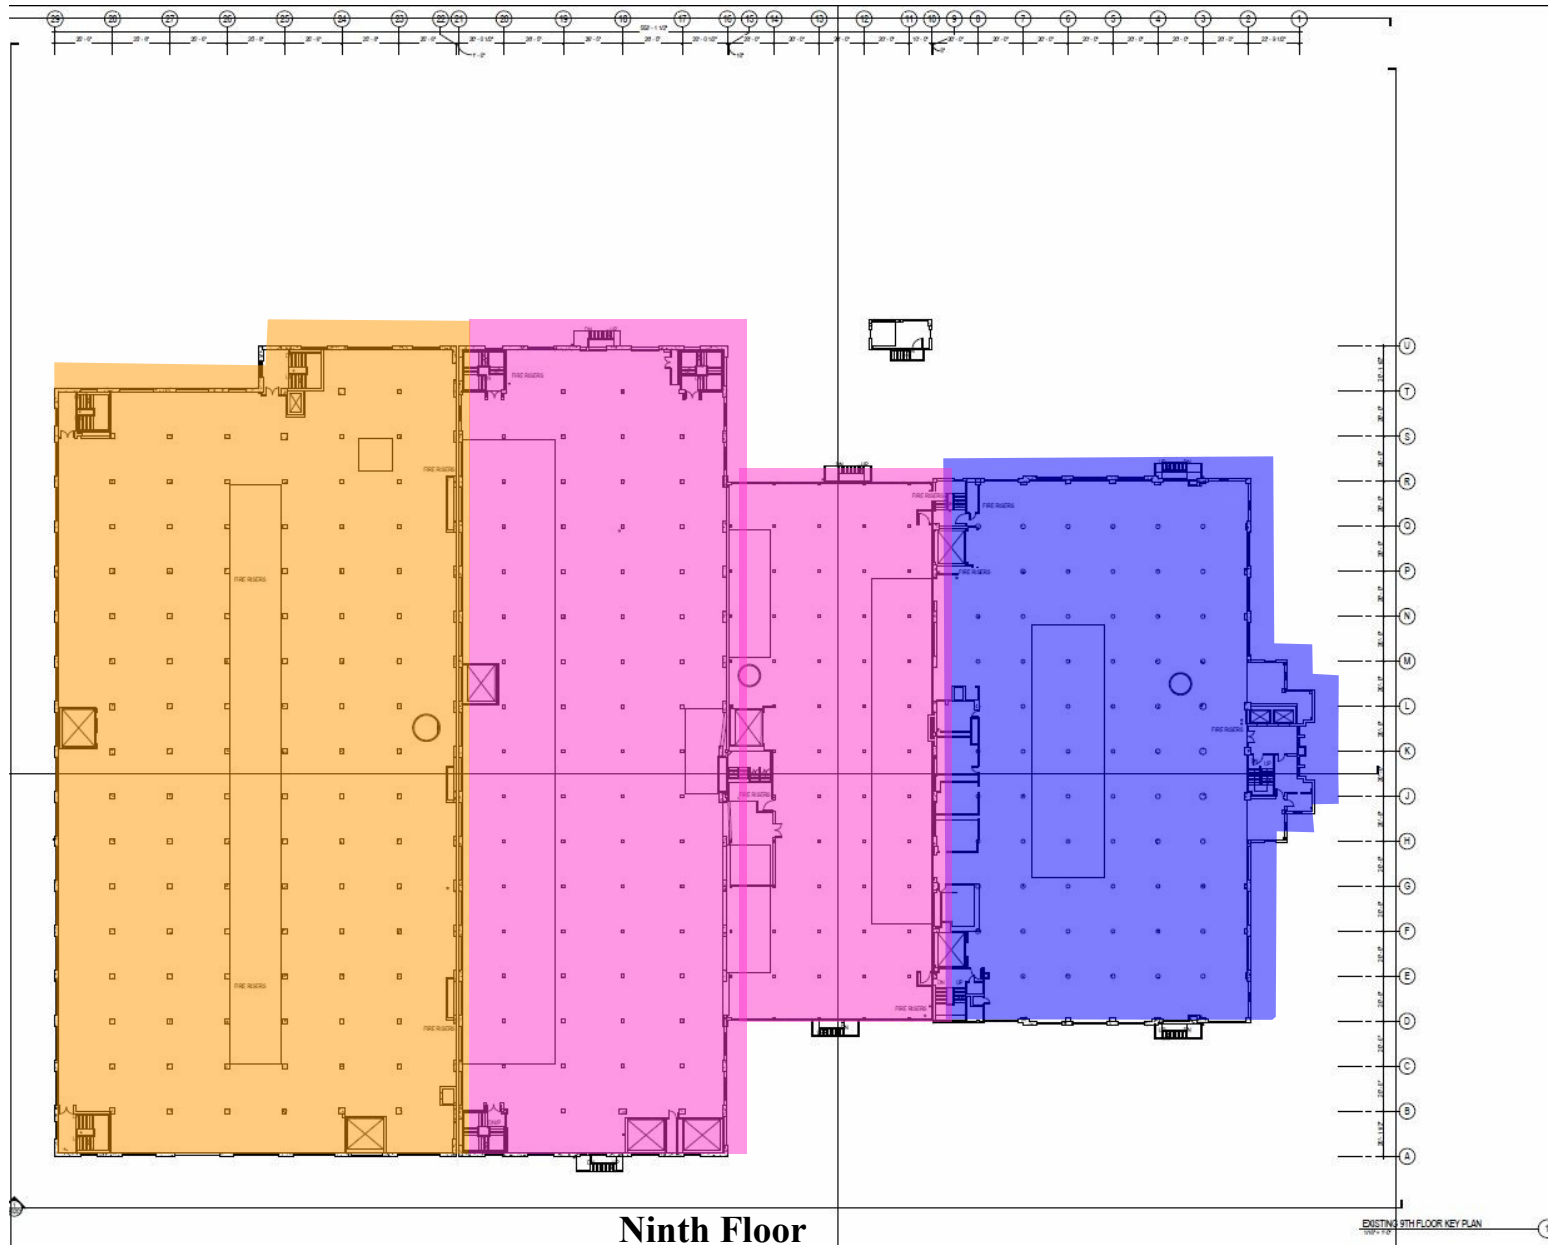
**NATIONAL REGISTER AMENDMENT
SEARS, ROEBUCK, & COMPANY MAIL ORDER BUILDING
2650 EAST OLYMPIC BOULEVARD
ATTACHMENT C: FLOOR-BY-FLOOR CONSTRUCTION HISTORY**

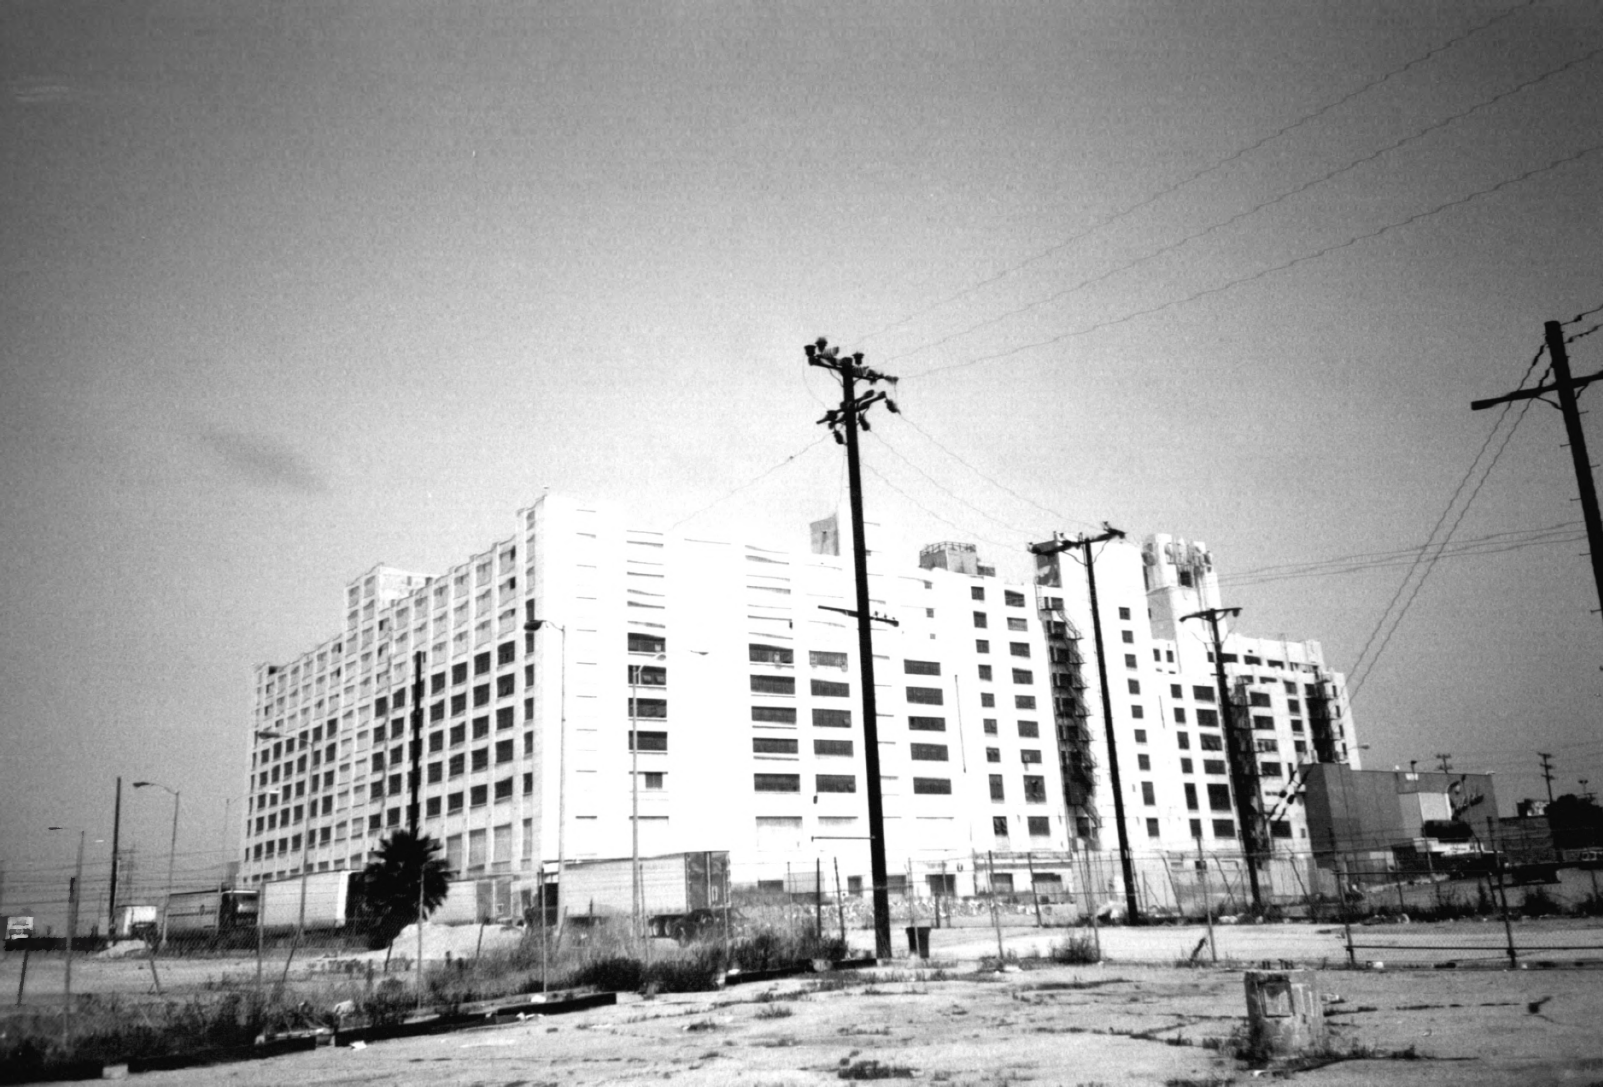
East elevation looking west

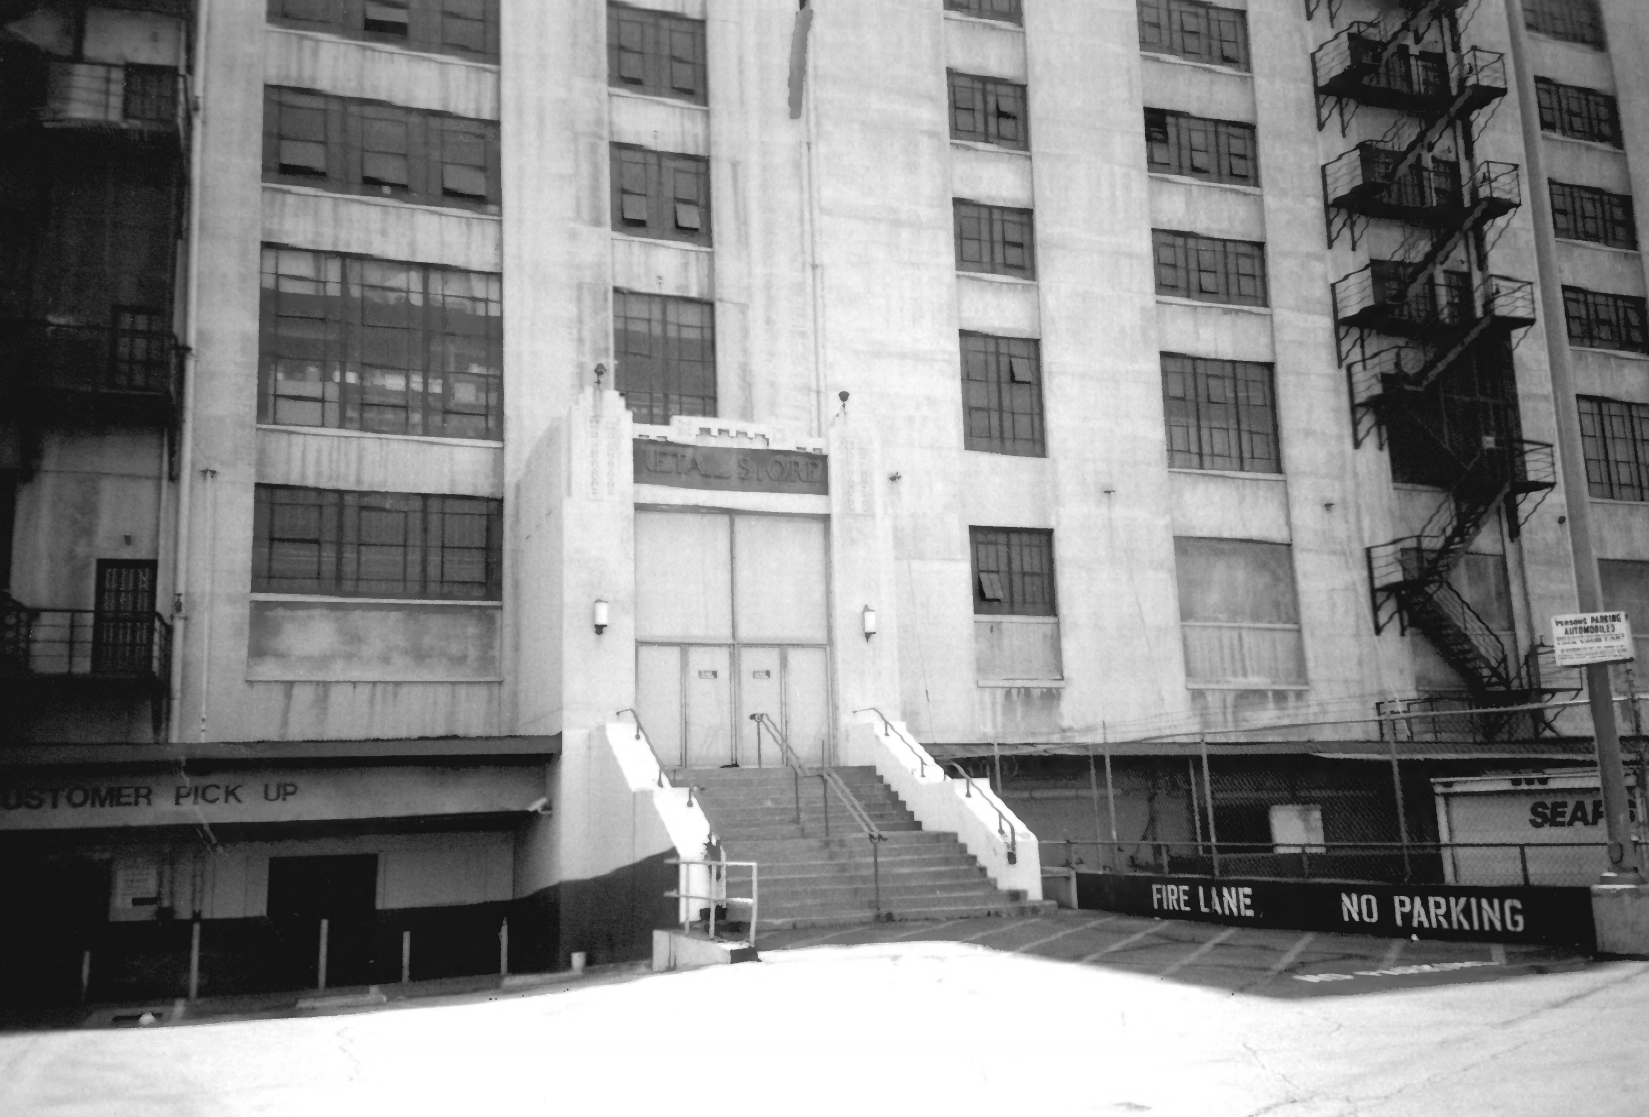
South + east elevations looking northwest

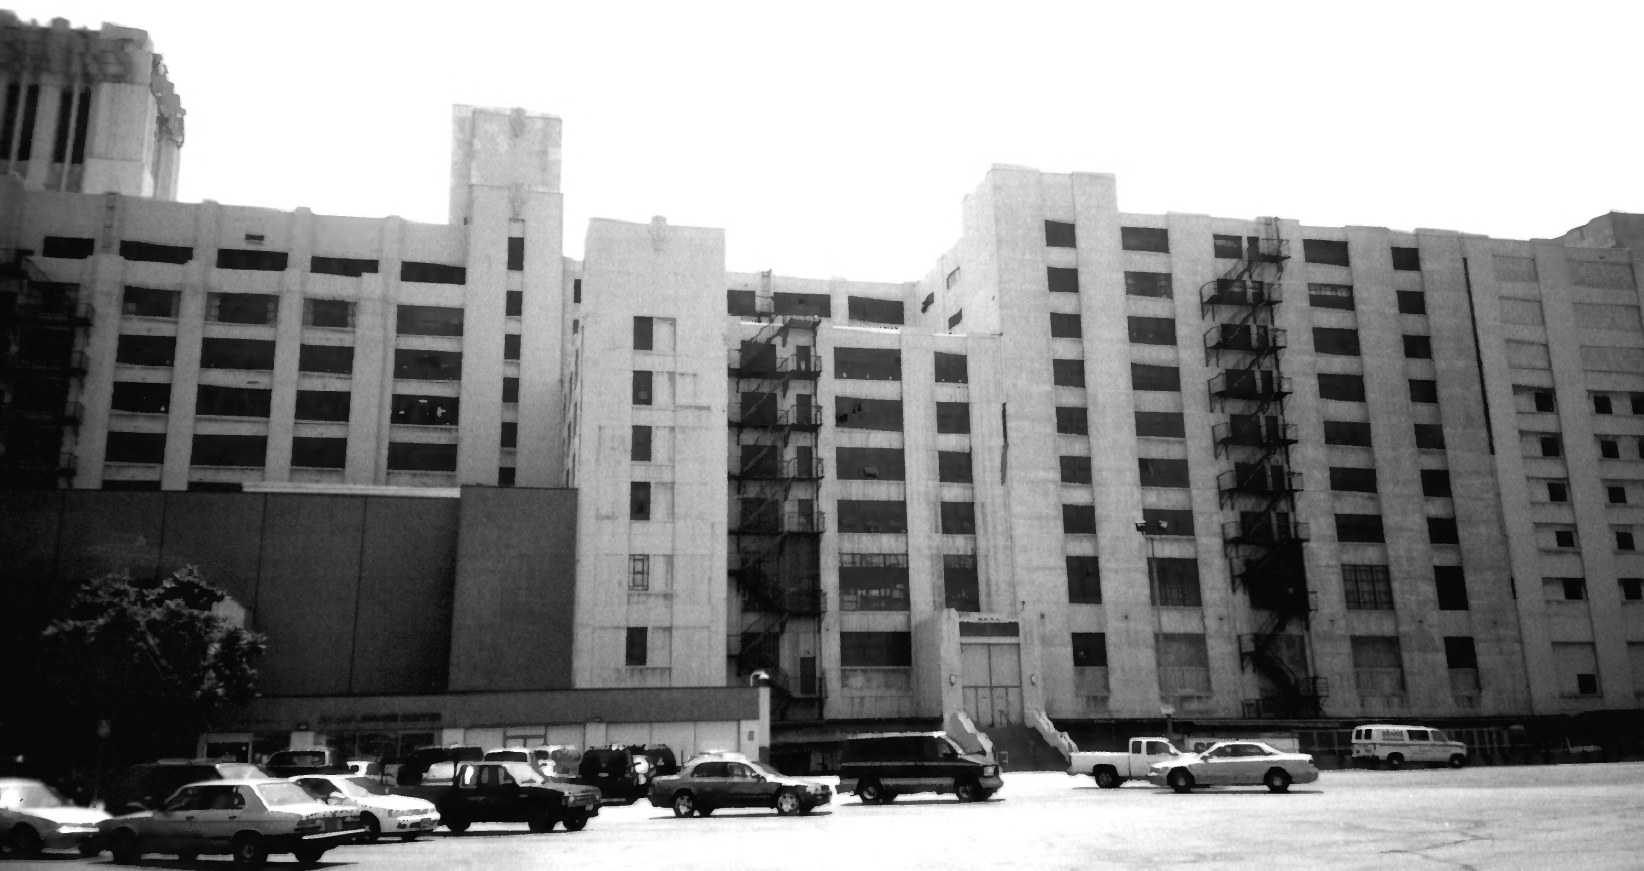
West elevation looking east at 1929

Side entrance

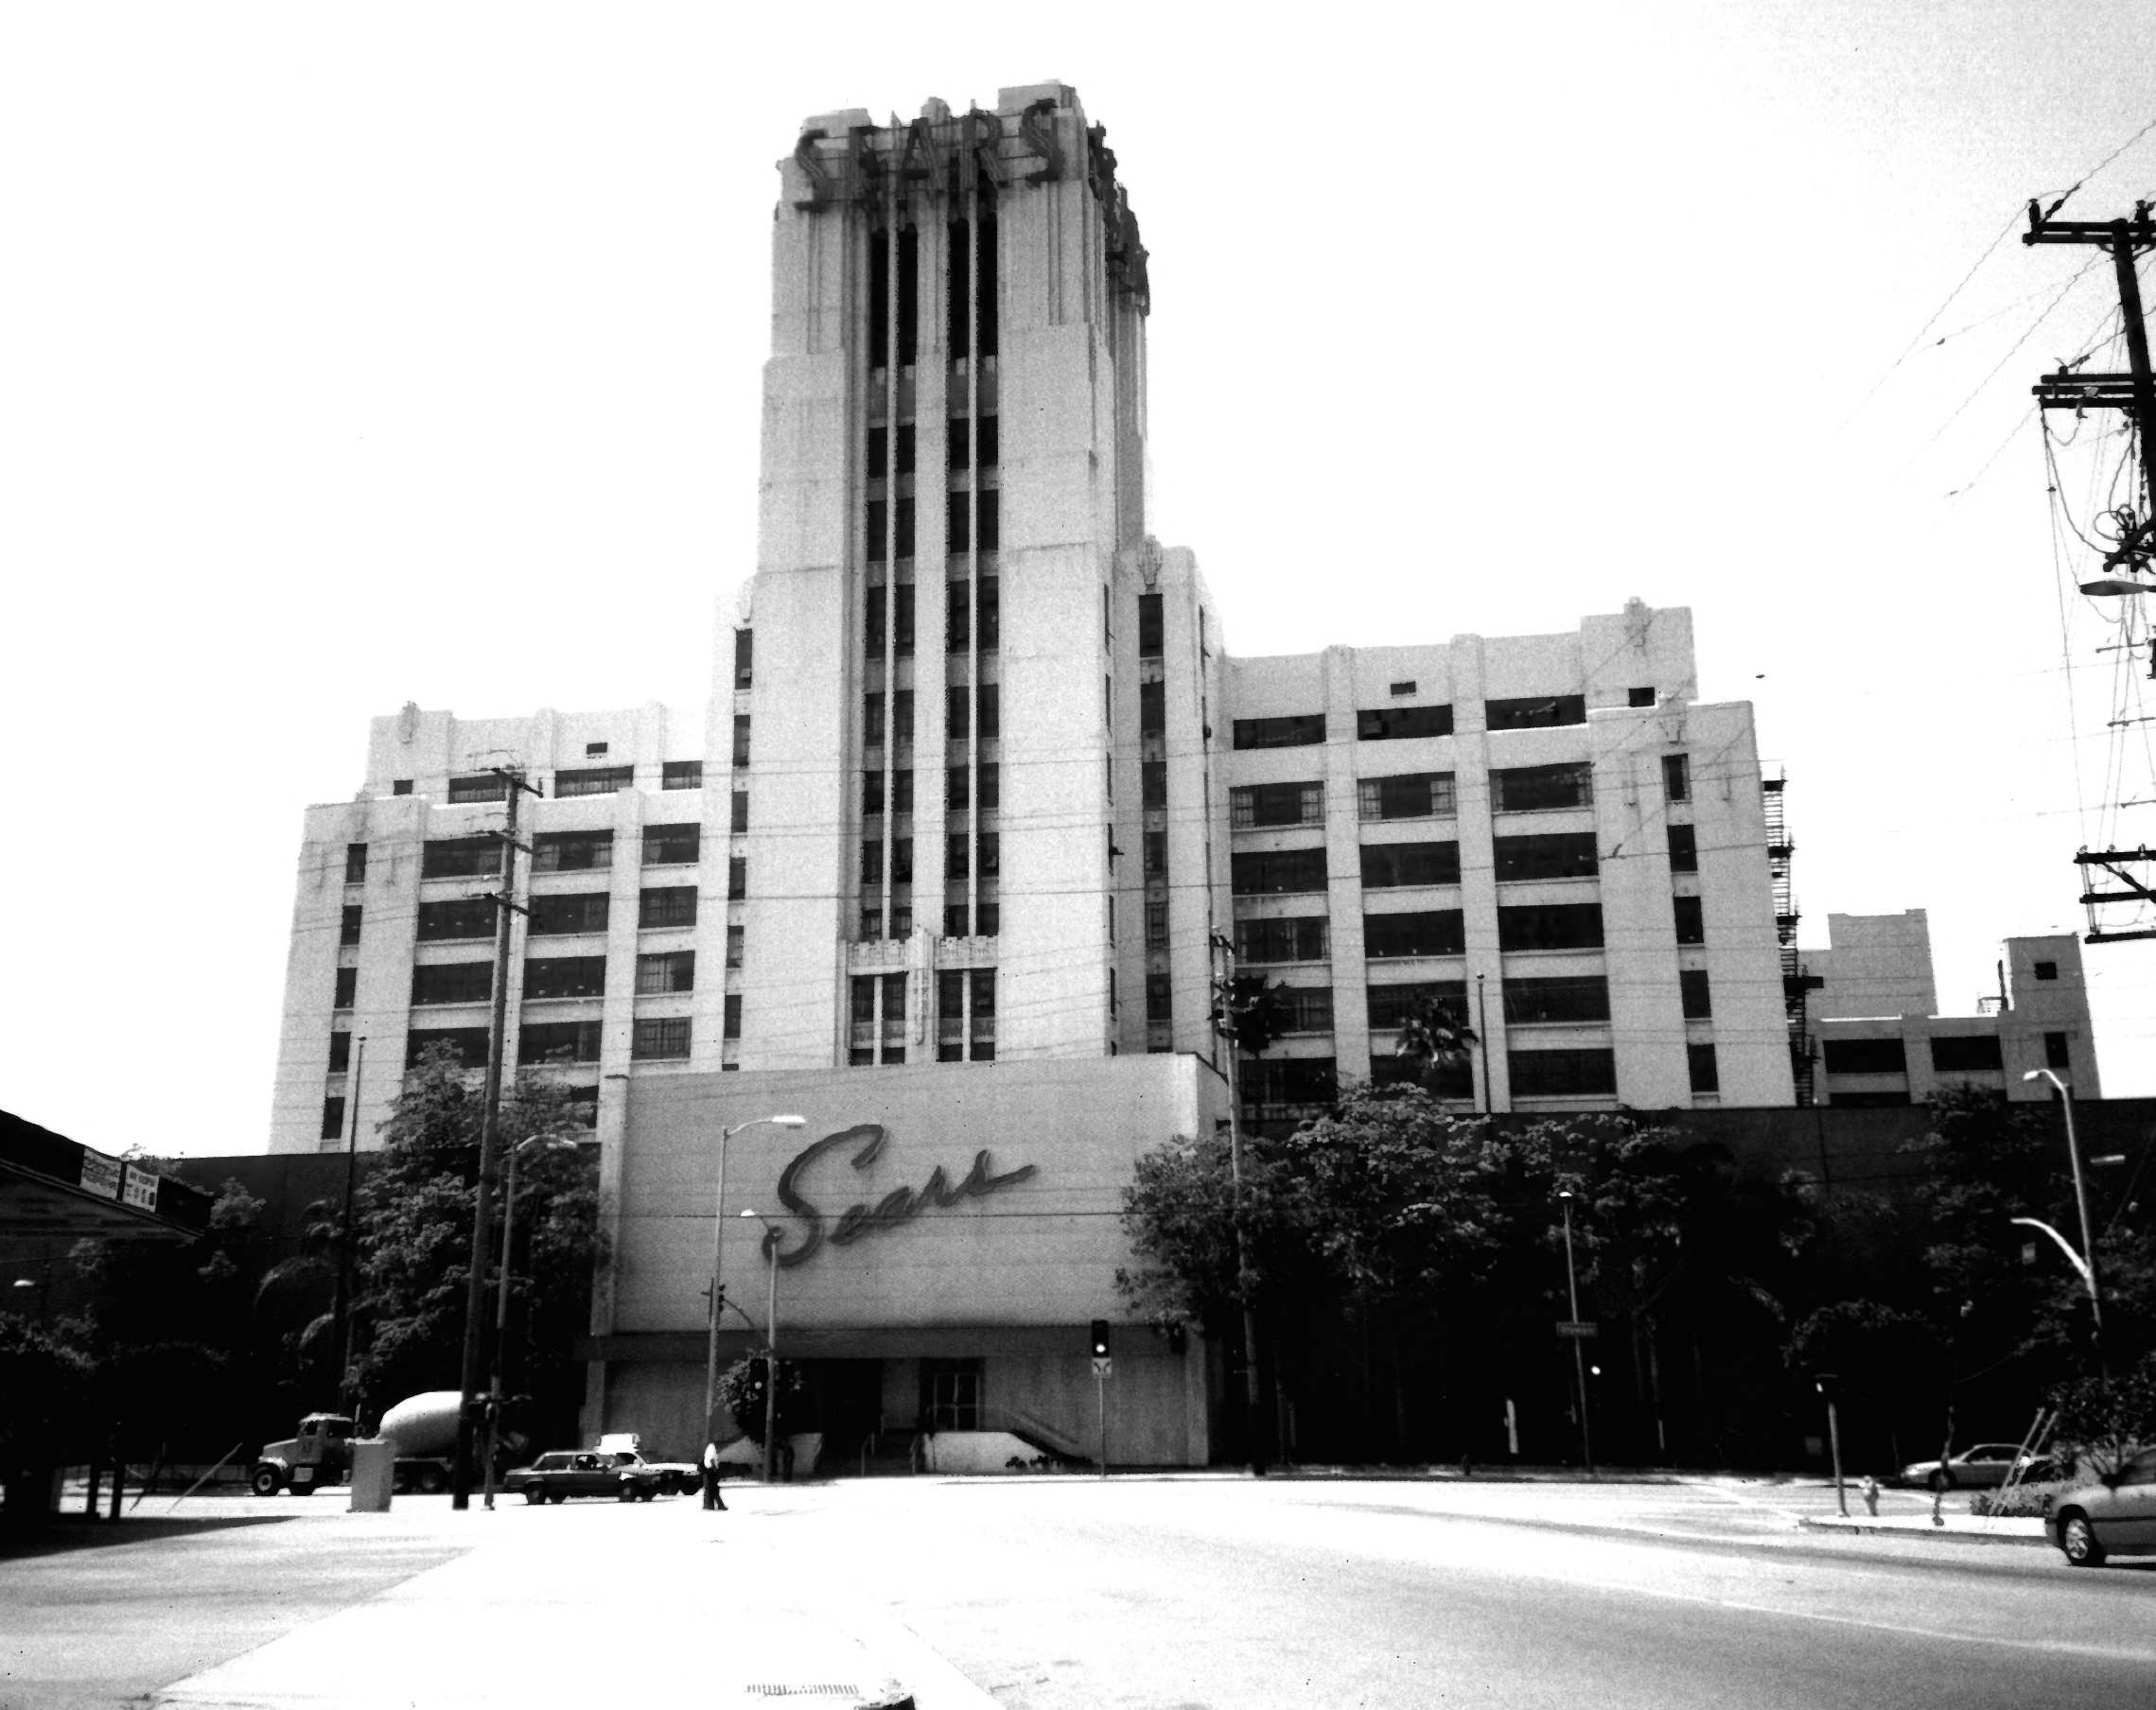
West elevation looking east
